TECHNICAL REPORTS FOR 1999

APPLIED GEOLOGY PROGRAM

Report of Investigation 244
UTAH GEOLOGICAL SURVEY
a division of
Utah Department of Natural Resources

February 2000

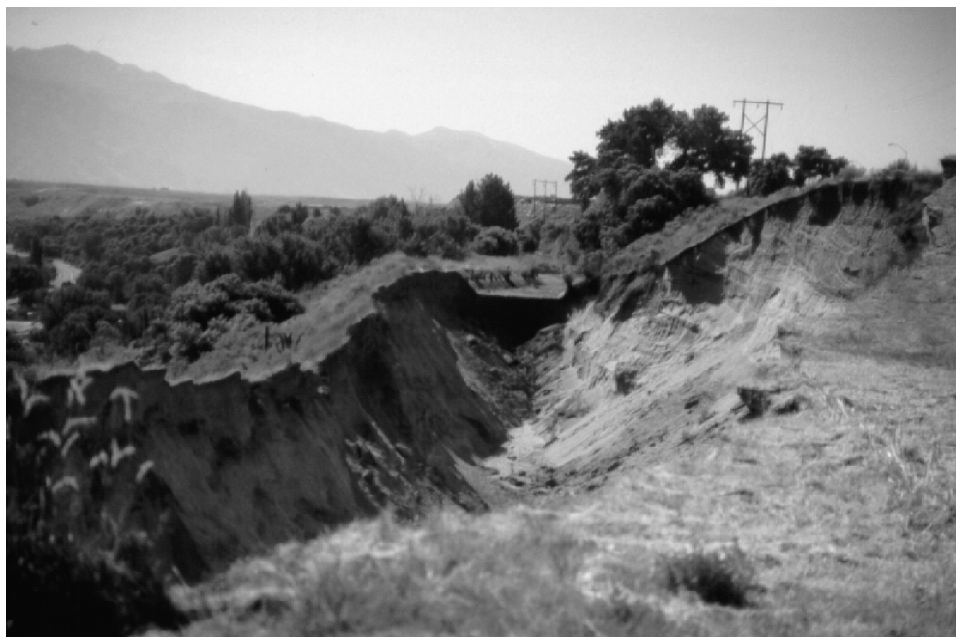
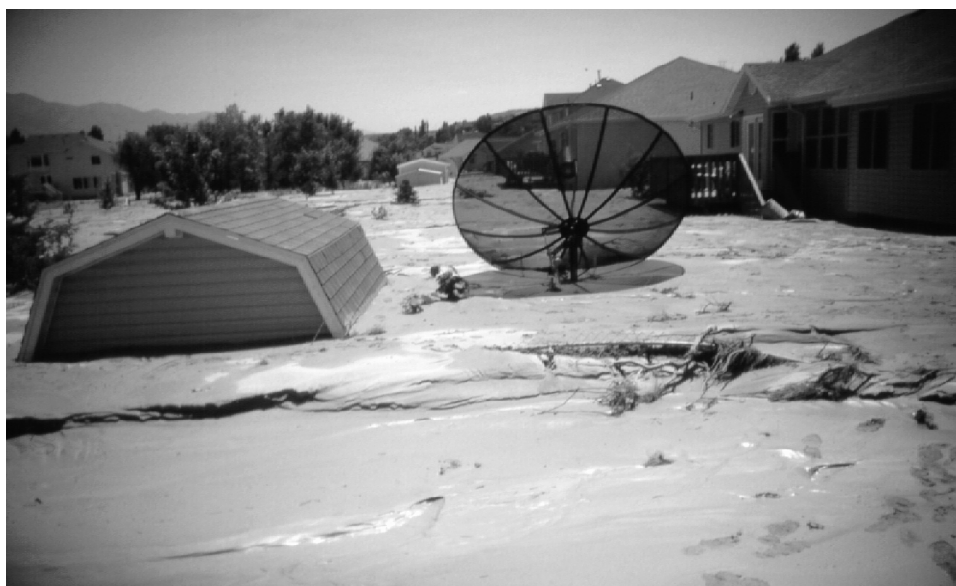
Cover photos: Views of breached canal and backyards in the Pinebrook subdivision in Riverdale the morning after the July 11, 1999 Davis-Weber Canal failure. Photograph credits: Bill Black.
